Additional file 1: Quality control of the assemblies

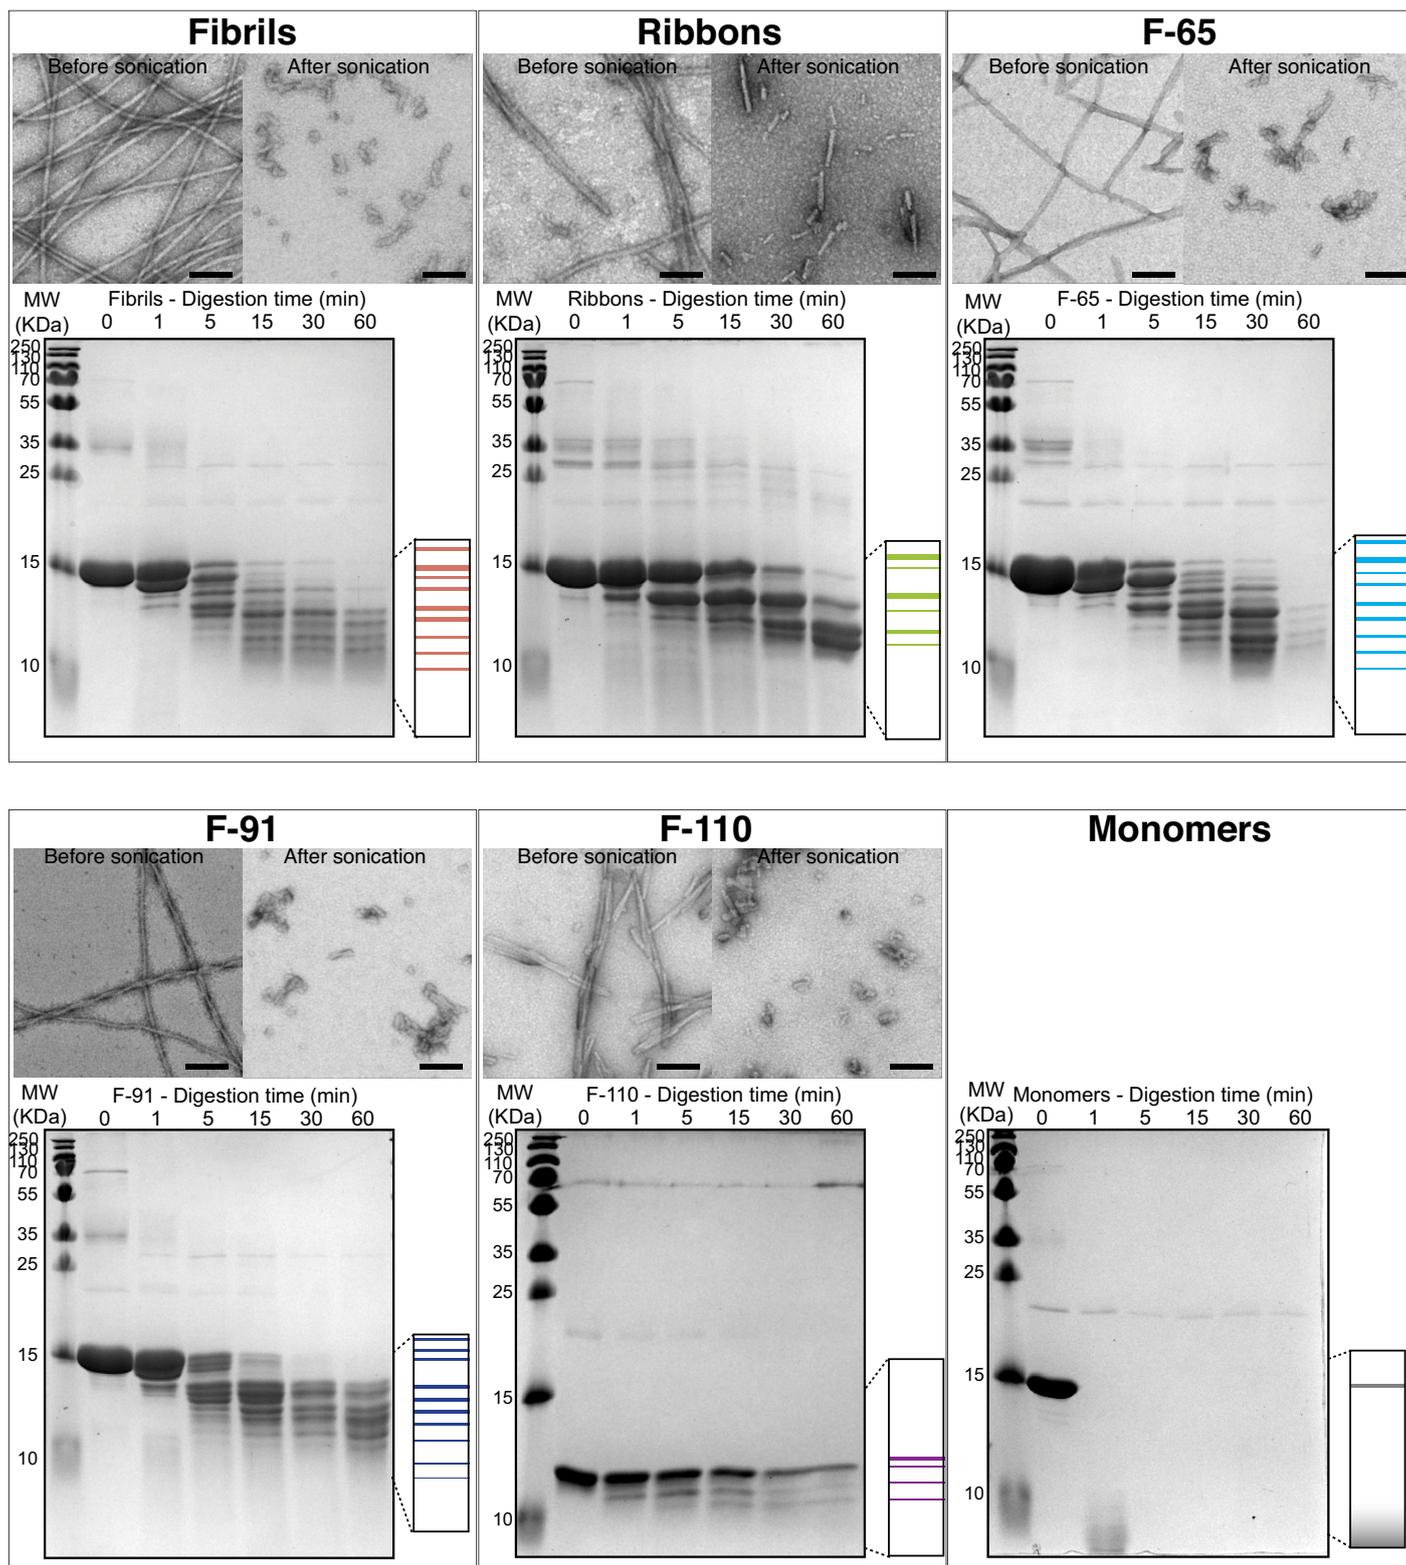
The quality of the assemblies was verified by electron microscopy, and by checking limited proteolysis profiles. Transmission electron microscopy (TEM) images of the assemblies were obtained after negative-staining by uranyl acetate. Scale bar: 200 nm

Proteinase-K digested samples collected from 0 to 60 min after addition of protease are visualized after migration on SDS-PAGE (15%) and Coomassie staining. Next to the gels, we represented the proteolysis profile (10 to 15 KDa) as a “barcode” that is specific and unique to each strain.
